6.7 THE AIRCRAFT STRUCTURAL MODEL

6.8 AIRCRAFT IMPACT MODELING

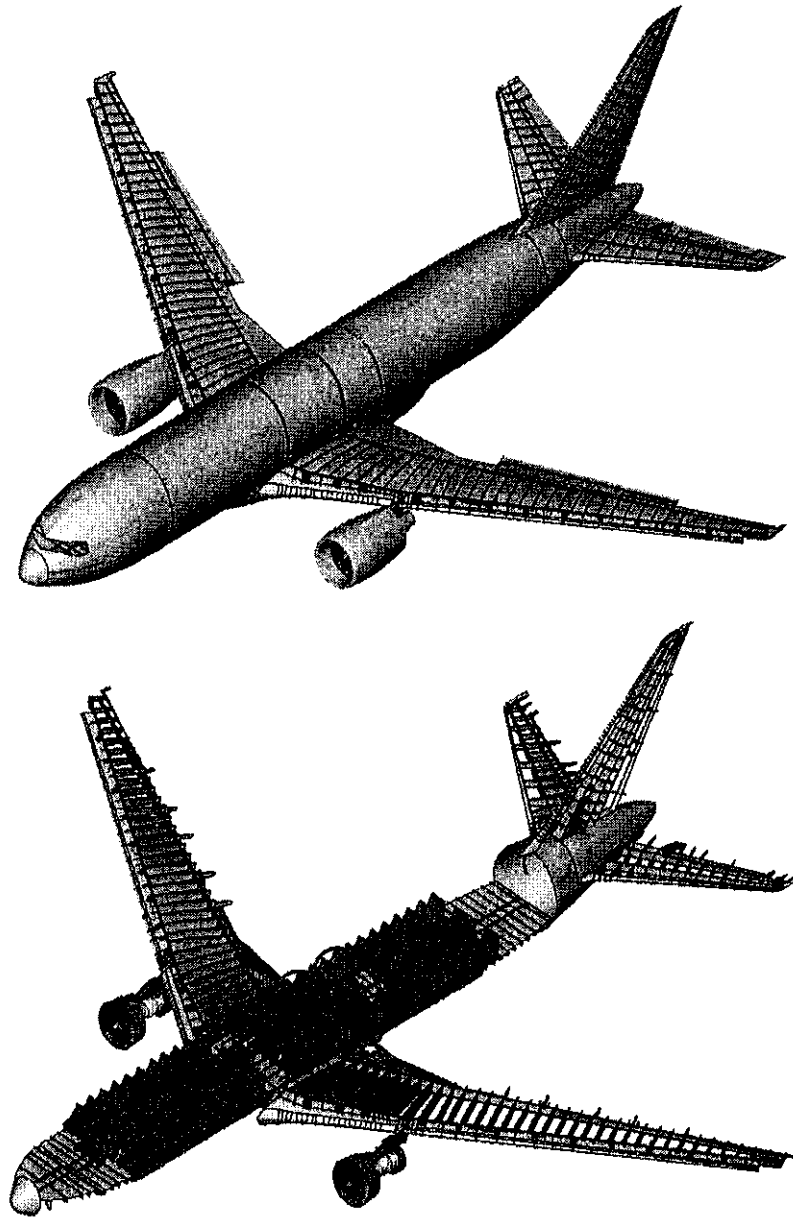
Due to their similarity, the two Boeing 767-200ER aircraft were represented by a single, finite element model, two views of which are shown in Figure 6-13. The model consisted of about 800,000 elements. The typical element dimensions were between 1 in. and 2 in. for small components, such as spar or rib flanges, and 3 in. to 4 in. for large parts such as the wing or fuselage skin. Structural data on which to base the model were collected from the open literature, electronic surface models and CAD drawings, an inspection of a 767-300ER, Pratt and Whitney Engine Reference Manuals, American Airlines and United Airlines, and the Boeing Company website.

Figure 6-13. Finite element model of the Boeing 767-200ER.

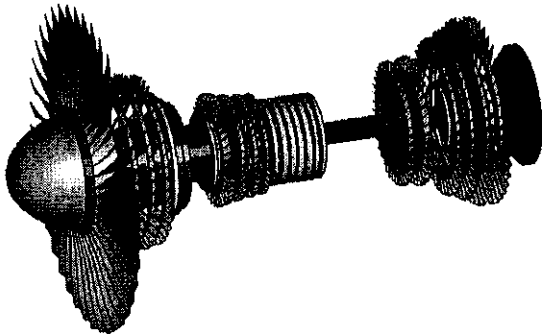
Figure 6–14. Pratt & Whitney PW4000 turbofan engine model.

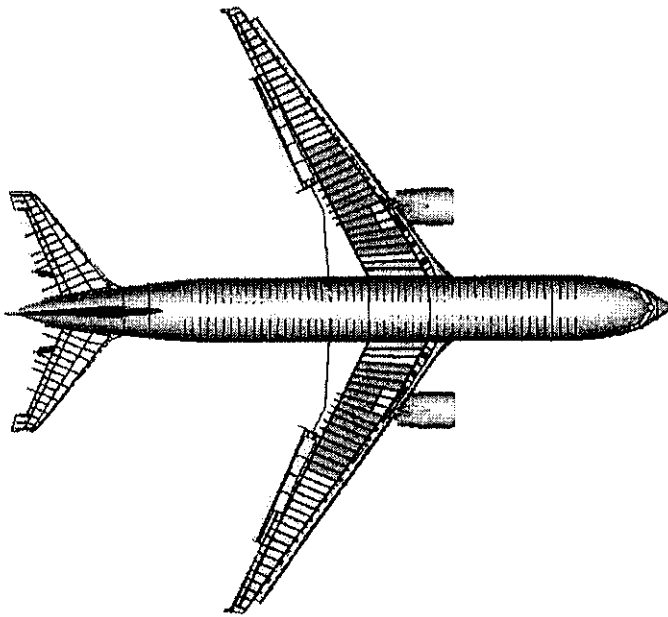
Figure 6–15. Boeing 767-200ER showing the jet fuel distribution at time of impact.

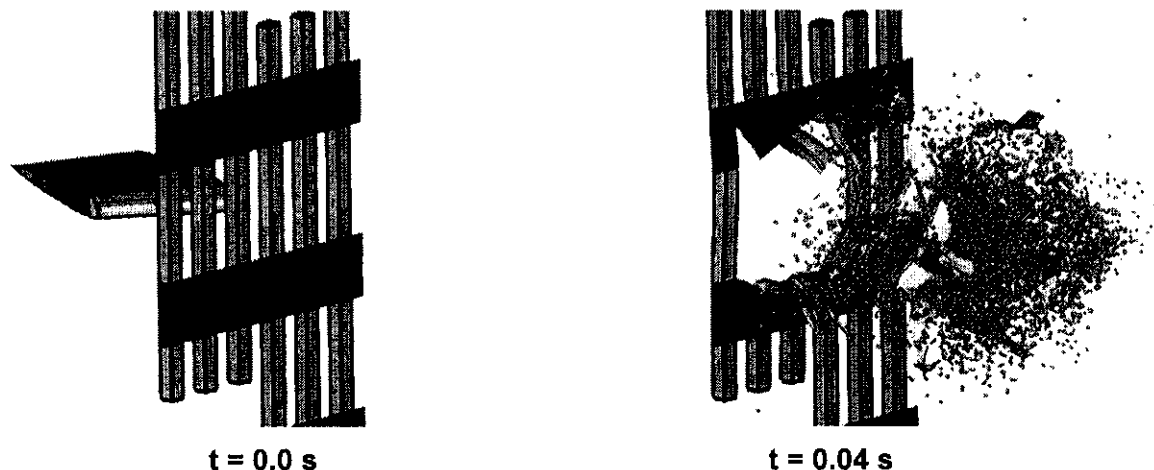
Figure 6–16 shows two frames from the last of these analyses, with the wing segment entering from the left, being fragmented as it penetrates the exterior columns, and spraying jet fuel downstream.

Figure 6–16. Calculated impact on an exterior wall by a fuel-laden wing section.

- Moving at 500 mph, an engine broke any exterior column it hit. If the engine missed the floor slab, the majority of the engine core remained intact and had enough residual momentum to sever a core column upon direct impact.
- The impact of the inner half of an empty wing significantly damaged exterior columns but did not result in their complete failure. Impact of the same wing section, but filled with fuel, did result in failure of the exterior columns.

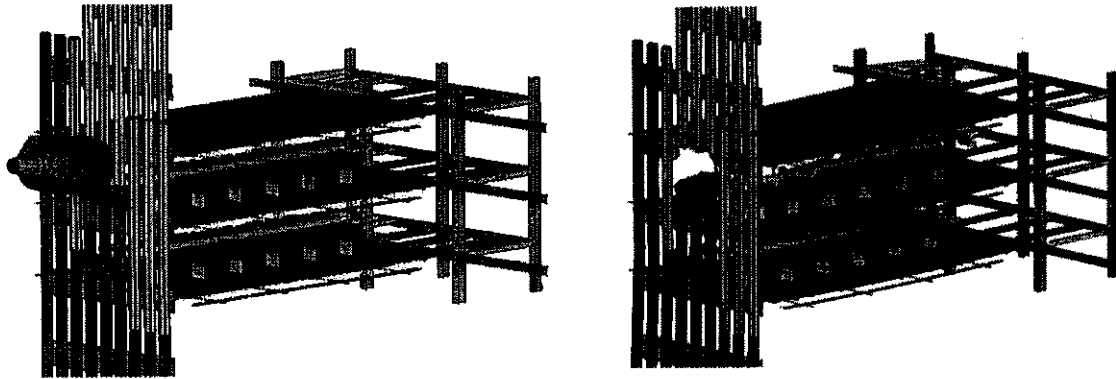
Next, a series of simulations were performed for intermediate-sized sections of a tower. These subassembly analyses investigated different modeling techniques and associated model sizes, run times, numerical stability, and impact response. Six simulations were performed of an aircraft engine impacting a subassembly that included structural components from the impact zone on the north face of WTC 1, exterior panels, truss floor structures, core framing, and interior contents (workstations). One response of the structure to the engine impact is shown in Figure 6–17.

Figure 6–17. Response of a tower subassembly model to engine impact.

- The mass of the concrete floor slab and nonstructural contents had a greater effect on the engine deceleration and subsequent damage than did the concrete strength.
- Variation of the failure criteria of the welds in the exterior columns did not result in any noticeable difference in the damage pattern or the energy absorbed by the exterior panels.

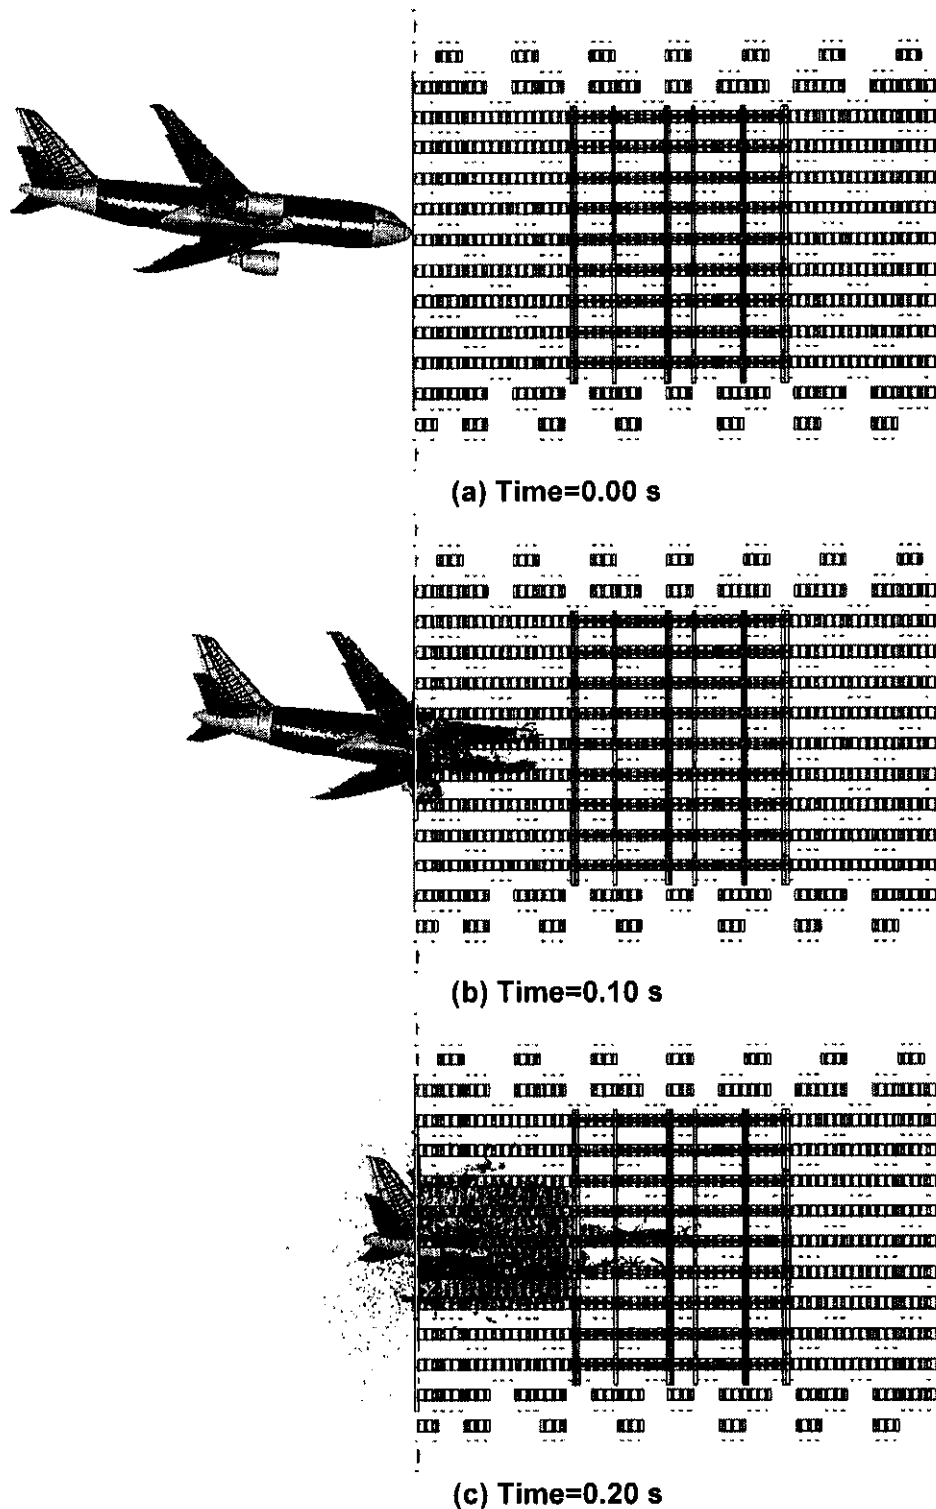
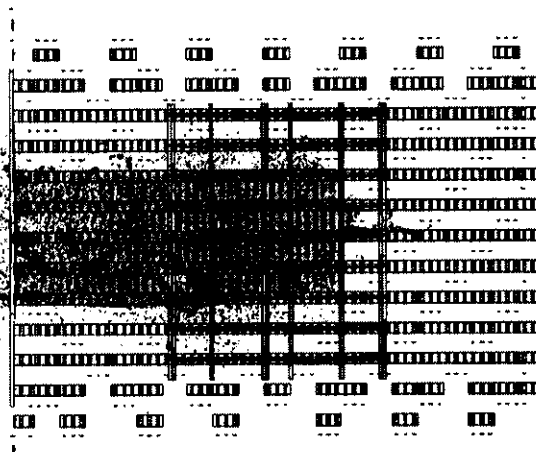
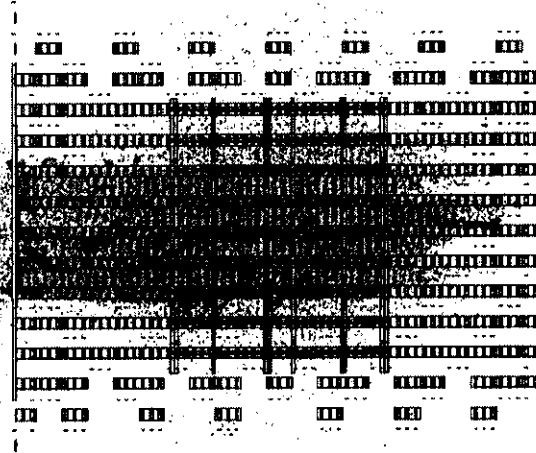
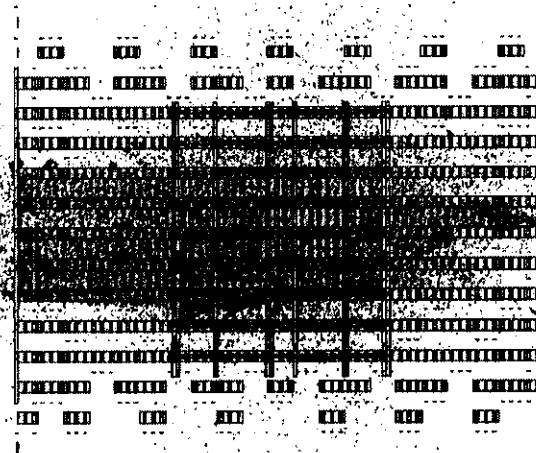
These simulations each took about 2 weeks on a 12-node computer cluster. Figure 6–18 shows six frames from the animation of one such simulation.

Figure 6–18. Side view of simulated aircraft impact into WTC 1, Case B.

As shown in Figure 6–18, the aircraft impact simulations explicitly included the fracture of walls in the debris path and the “bulldozing” of furnishings. Damage to the impacted furnishings was not modeled. Walls and furnishings outside the debris paths were undamaged in the simulations.

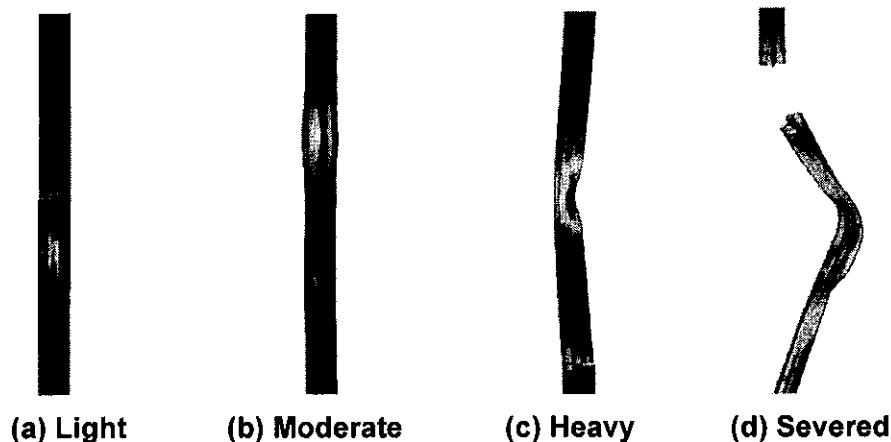
- Lightly damaged column: column impacted, but without significant structural deformation;
- Moderately damaged column: visible local distortion, but no deformation of the column centerline;
- Heavily damaged column: Permanent deflection of the column centerline; and
- Failed column: Column severed.

Figure 6–19. Column damage levels.

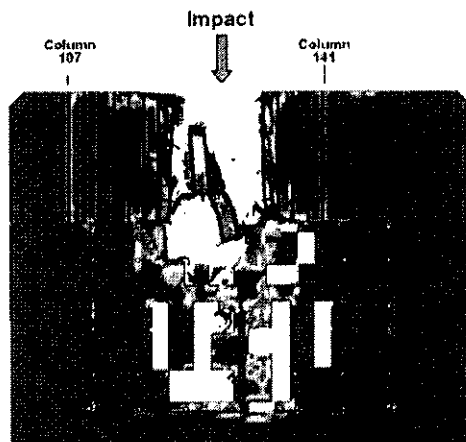
Figure 6–20 shows the calculated damage to a floor slab. Figure 6–21 shows the response of the furnishings and the jet fuel to the impact. Figures 6–22 through 6–25 show the combined damage for all floors for the four global simulations. The latter proved useful in visualizing the extent of aircraft impact in one graphic image.

Figure 6–20. Case B damage to the slab of floor 96 of WTC 1.

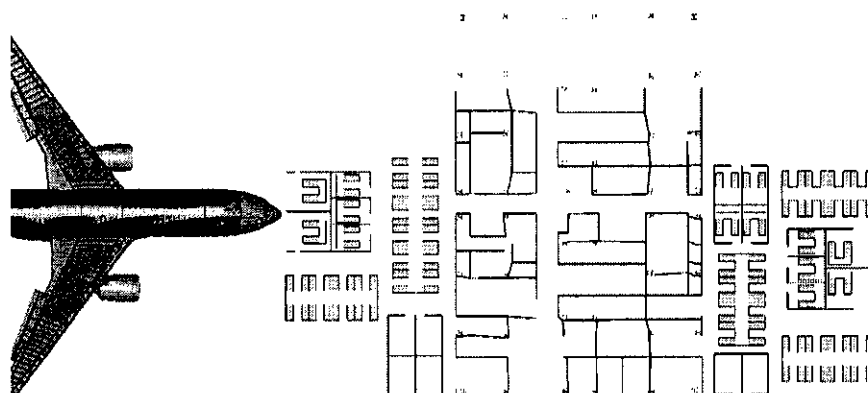
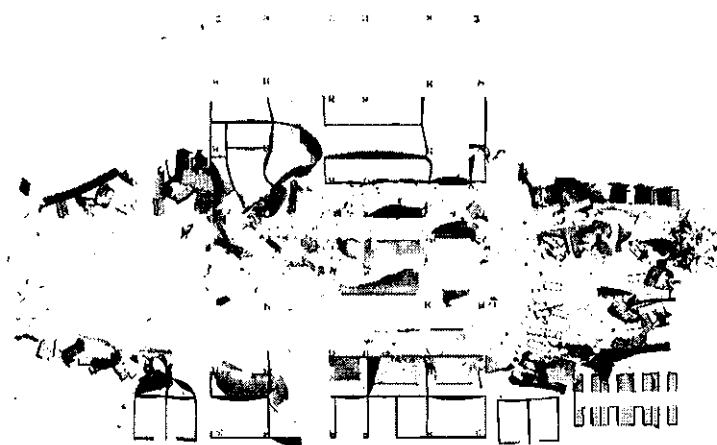
(a) Pre-impact configuration

(b) Calculated impact response

(c) Calculated impact response (fuel removed)

Figure 6–21. Case B simulation of response of contents of 96th floor of WTC 1.

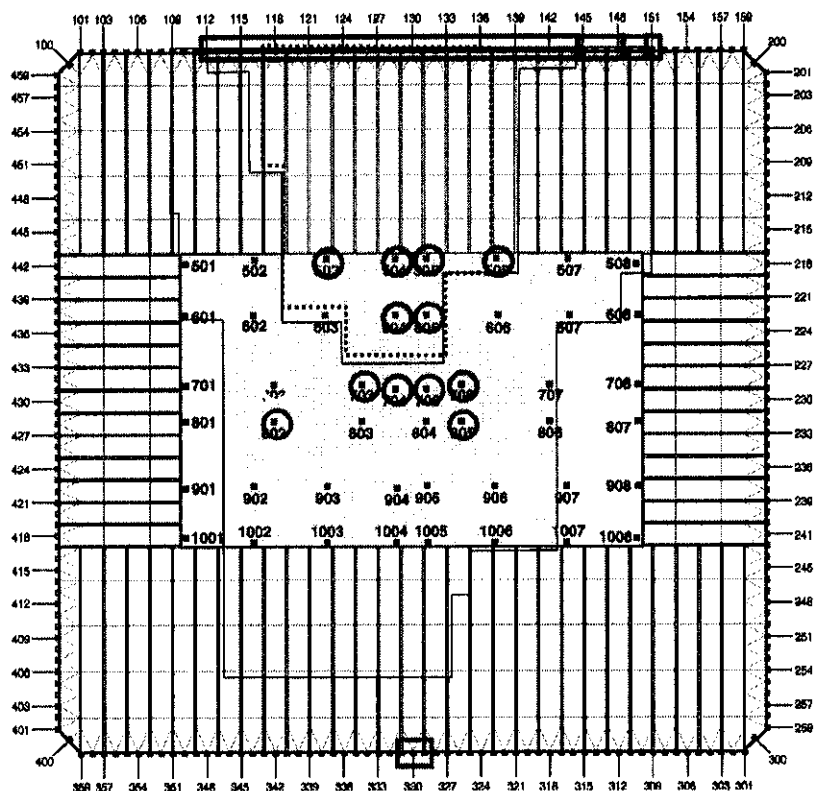
Figure 6-22. Combined structural damage to the floors and columns of WTC 1, Case A.

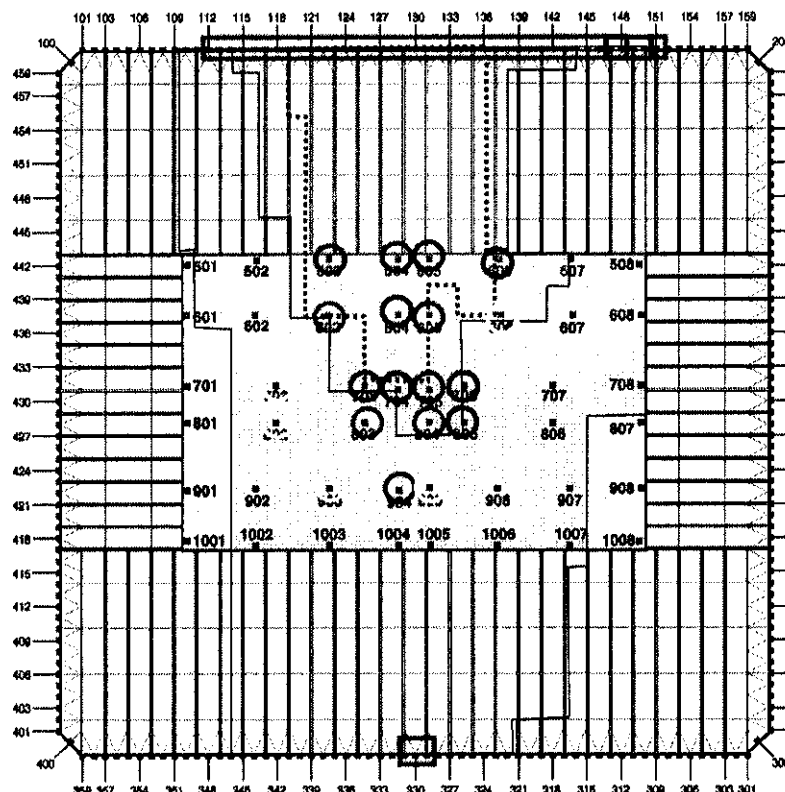
Figure 6-23. Combined structural damage to the floors and columns of WTC 1, Case B.

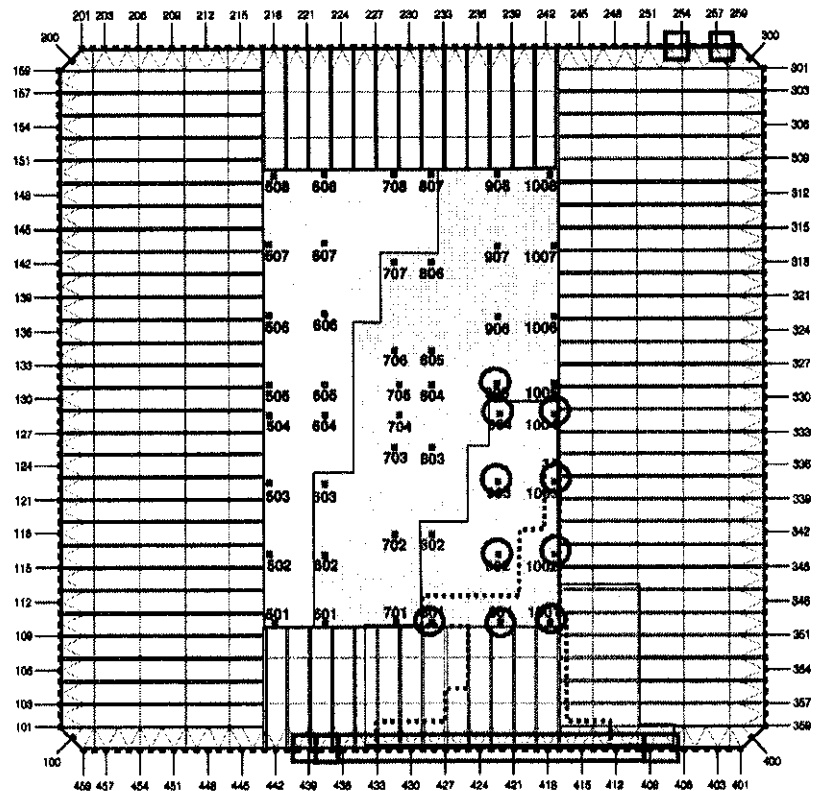
Figure 6-24. Combined structural damage to the floors and columns of WTC 2, Case C.

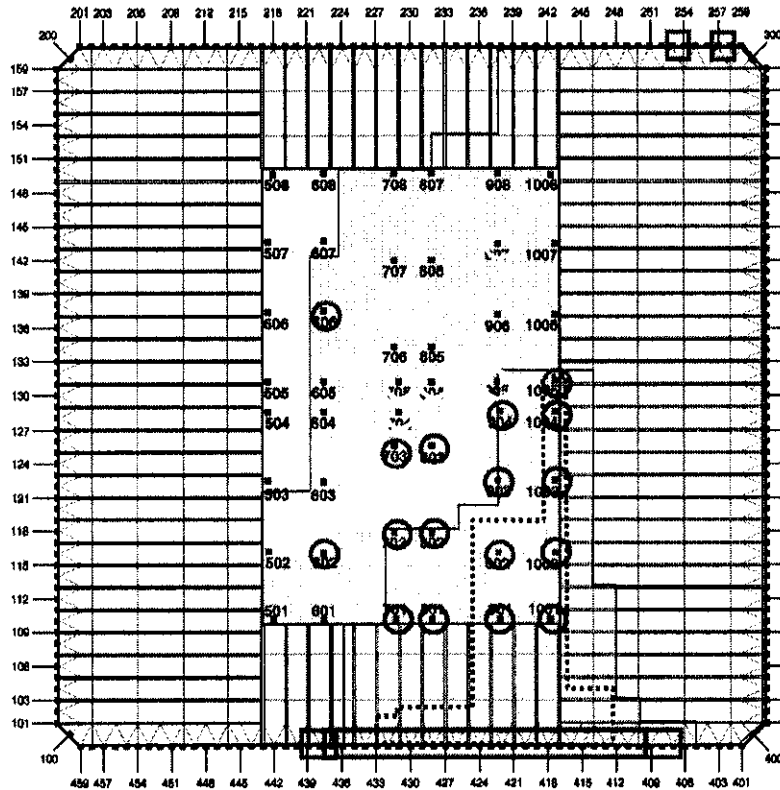
Figure 6-25. Combined structural damage to the floors and columns of WTC 2, Case D.

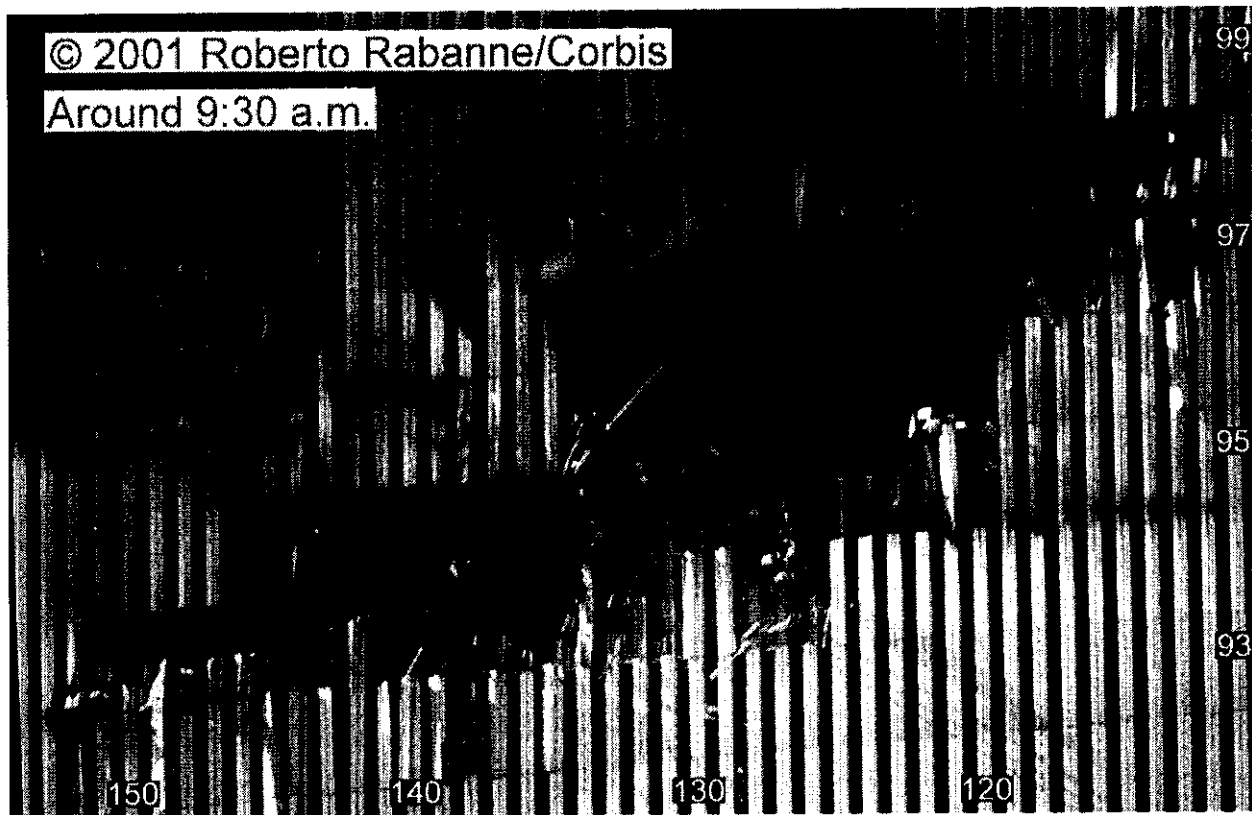
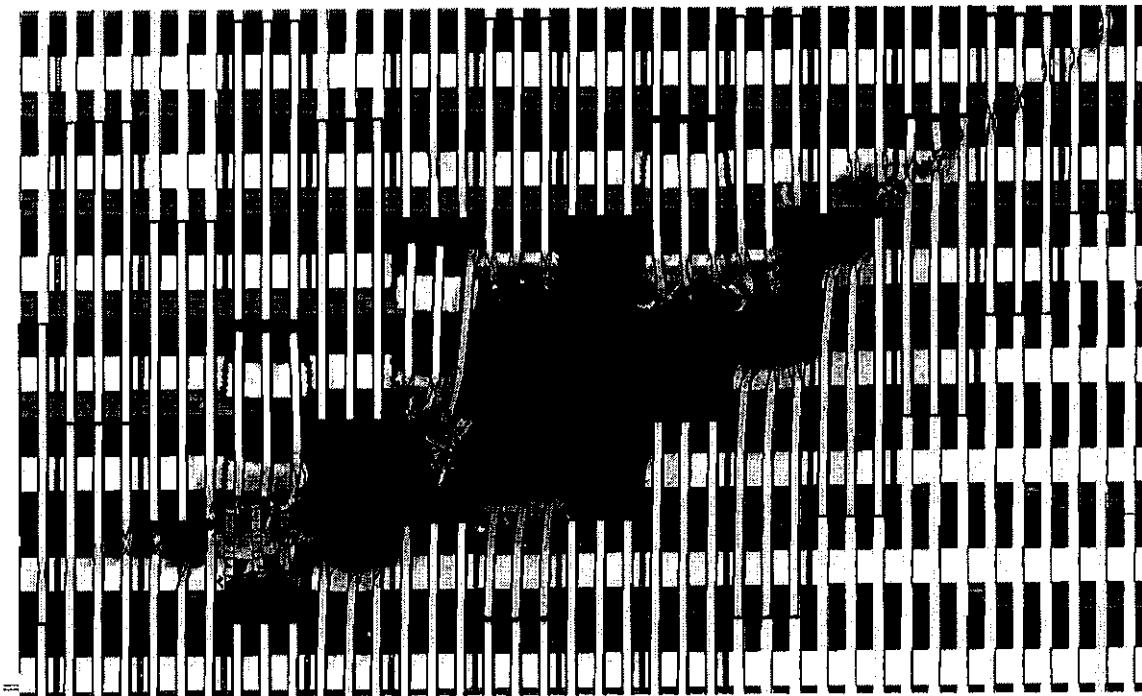
(a) Observed Damage

(b) Calculated damage

Figure 6-26. Observed and Case A calculated damage to the north face of WTC 1.

Assessment of the aircraft impact simulations of exterior damage to the towers involved comparing the predicted perimeter wall damage near the impact zone with post-impact photographs of the walls. Figure 6–26 shows a photograph of the north face of WTC 1 after impact and the results of the Case A simulation. The calculated silhouettes capture both the position and shape of the actual damage.

The predominance of green dots and the scarcity of red dots indicate that the overall agreement with the observed damage was very good. The agreement for Cases B and D was slightly lower.

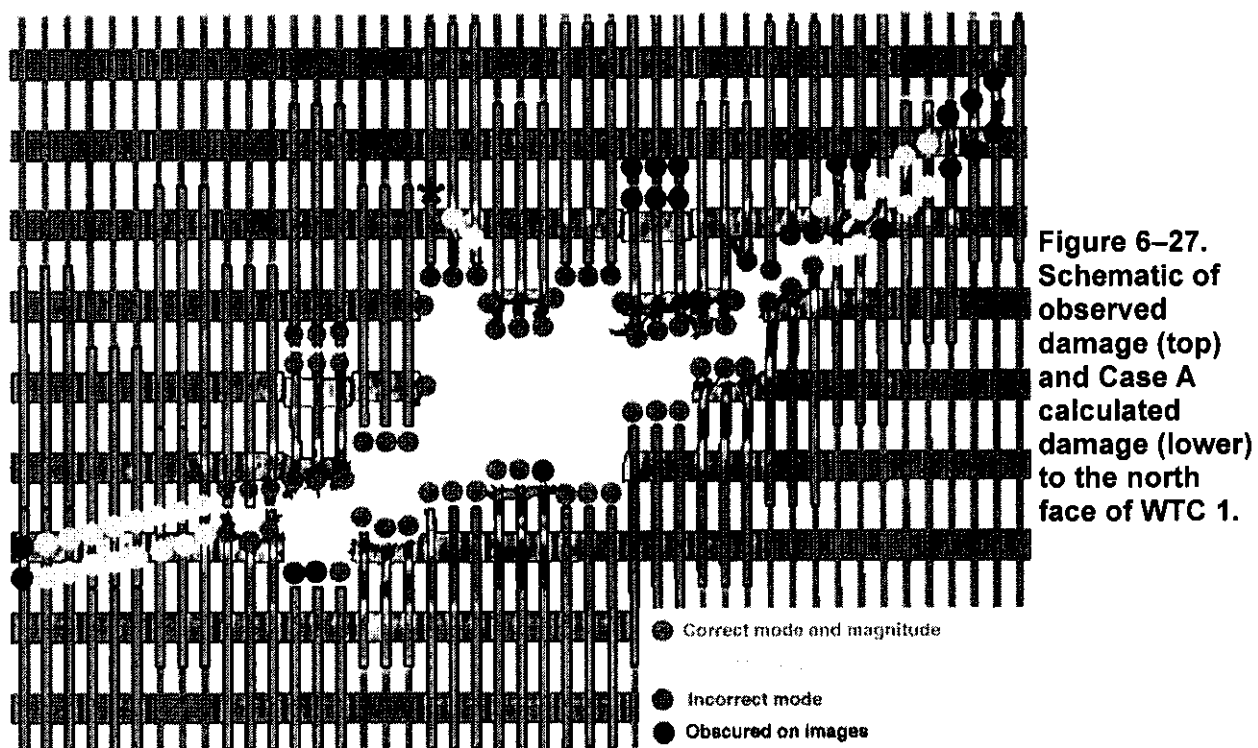
Figure 6-28. Schematic of observed damage (above) and Case C calculated damage (right) to the south face of WTC 2.

Figures 6–27 and 6–28 depict more detailed comparisons between the observed and calculated damage. The aircraft hole is shown in white. The colored dots characterize the mode in which the steel or connection failed (e.g., severed bolt, ripped weld) and the magnitude of the deformation of the steel:

- Green: proper match of failure mode and magnitude
- Yellow: proper match in the failure mode, but not the magnitude
- Red: neither the failure mode nor the magnitude matched
- Black: the observed damage was obscured by smoke, fire, or other factors

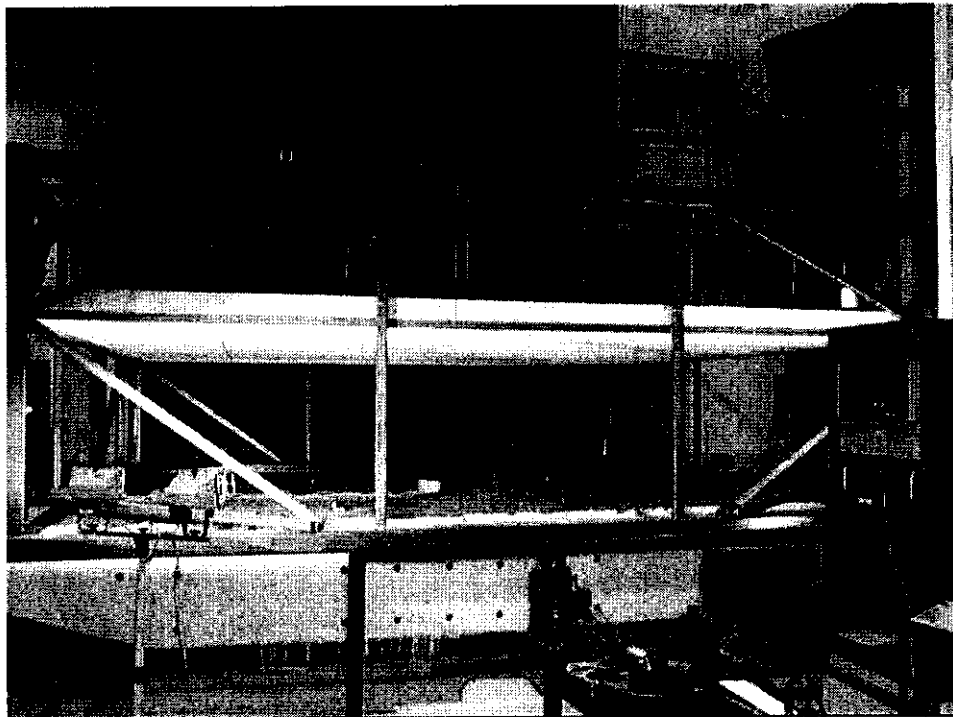
Figure 6–29. Ceiling tile system mounted on the shaking table.

The aircraft impact modeling did not include the ceiling tile systems. To estimate whether the tiles would survive the aircraft impact, the University at Buffalo, under contract to NIST, conducted tests of WTC-like ceiling tile systems using their shake table (Figure 6–29) and impulses related to those induced by the aircraft impact on the towers. The data indicated that accelerations of approximately 5g would most likely result in substantial displacement of ceiling tiles. Given the estimated impact accelerations of approximately 100g, NIST assumed that the ceiling tiles in the impact and fire zones were fully dislodged. This was consistent with the multiple reports of severely damaged ceilings (Chapter 7).

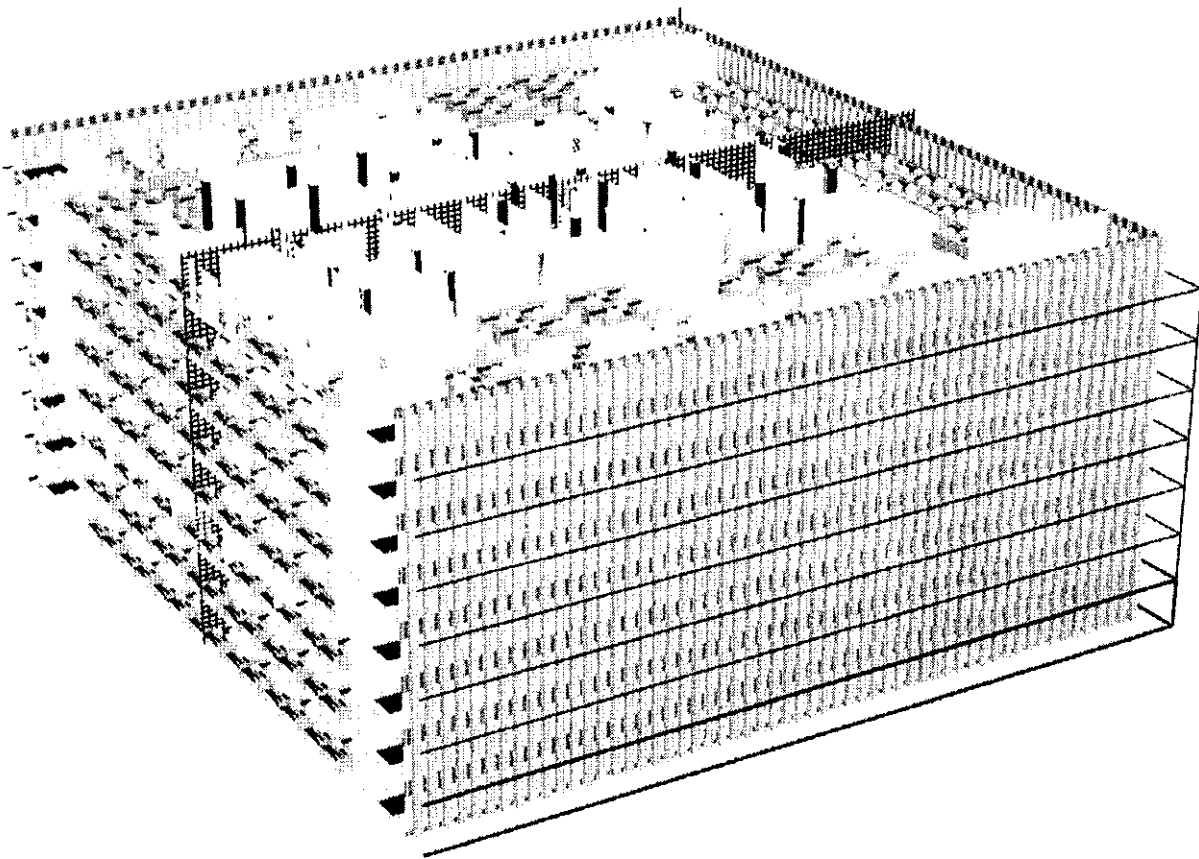
Figure 6–30. Eight floor model of WTC 1 prior to aircraft impact.

FDS represented the spaces in which the fires and their effluent were to be modeled as a grid of rectangular cells. These grids included the walls, floors, ceilings, and any other obstructions to the movement of air and fire. In the final simulations, the grid size was 0.5 m x 0.5 m x 0.4 m high (1.6 ft x 1.6 ft x 1.3 ft.). Each floor contained about 125,000 grid cells, and the nature of each cell was updated every 10 ms (100 times every second). The computations were performed using parallel processing, in which the fires on each floor were simulated on a different computer. At the end of each 10 ms update, the processors exchanged information and proceeded to the computations for the next time interval. Each simulation of 105 min of fires for WTC 1 took about a week on eight Xeon computers with a combined 16 GB of memory. The simulations for WTC 2, with fewer floors and 60 min of real time fires, took about half the time.

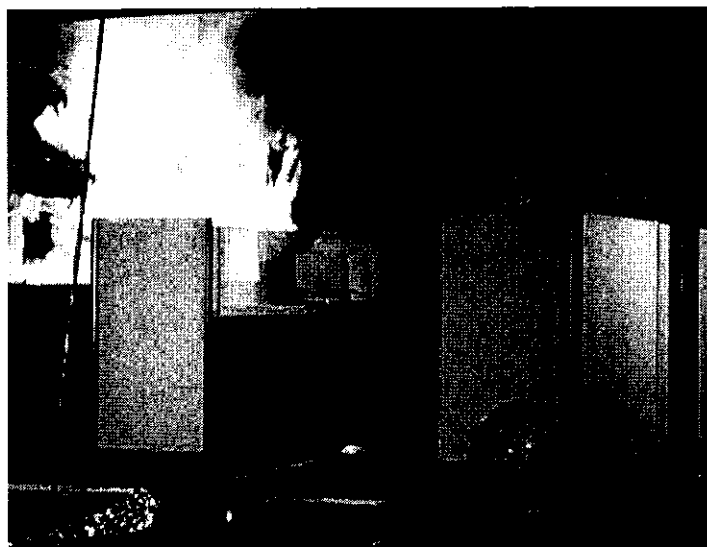
Figure 6–31. Fire test of a single workstation.

The floors of the tower on which the dominant burning occurred were characterized by large clusters of office workstations (Figure 1–11). NIST determined their combustion behavior from a series of single-workstation fire tests (Figure 6–31). In these highly instrumented tests, the effects of workstation type, the presence of jet fuel, and the presence of fallen inert material (such as pieces of ceiling tiles or gypsum board walls) on the burning surfaces were all assessed. While FDS properly captured the gross behavior of these fires, the state of modeling the combustion of real furnishings was still primitive. Thus, the results of this test series were used to refine the combustion module in FDS.

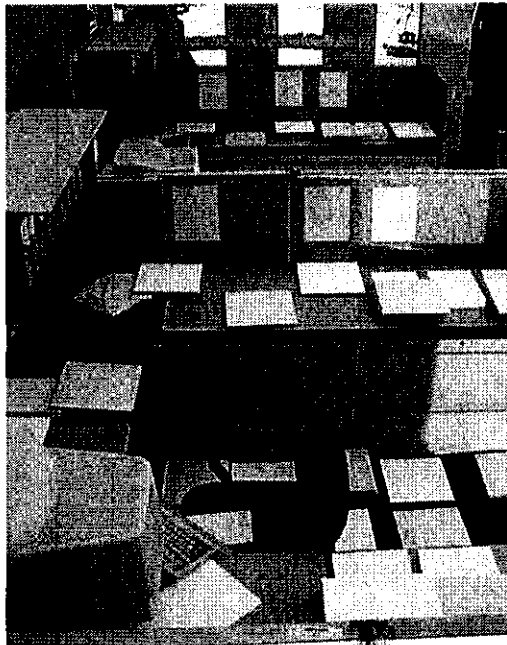
Figure 6–32. Interior view of a three-workstation fire test.

The second series was a preamble to the modeling of the actual WTC fires. Arrays of three WTC workstations were burned in a 35.5 ft by 23 ft by 11 ft high compartment (Figure 6–32). The tests examined the effects of the type of workstation, the presence of jet fuel, and the presence of fallen inert material on the burning surfaces. In one of the tests, the workstations were rubblized (Figure 6–33). Figure 6–34 depicts the intensity of the test fires. Figure 6–35 shows the measured and predicted heat release rate data from one of the tests in which there was no jet fuel nor inert material present.

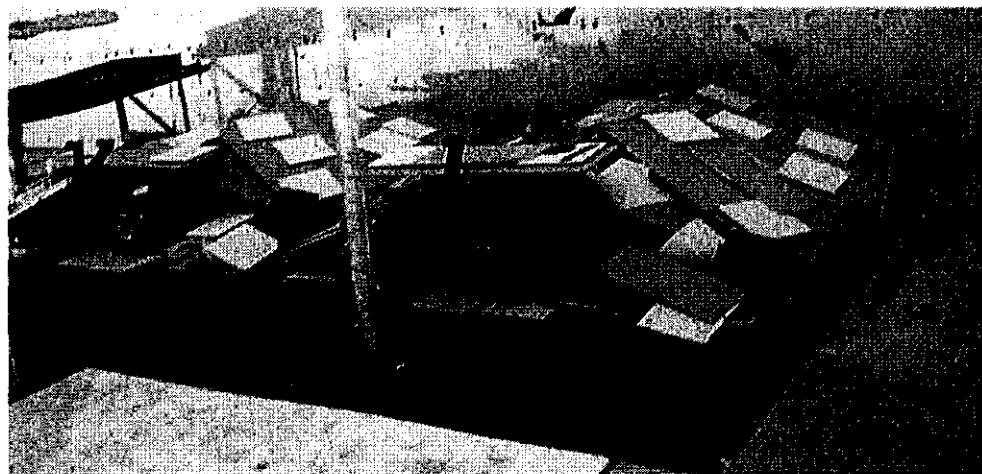
Figure 6–33. Rubblized workstations.

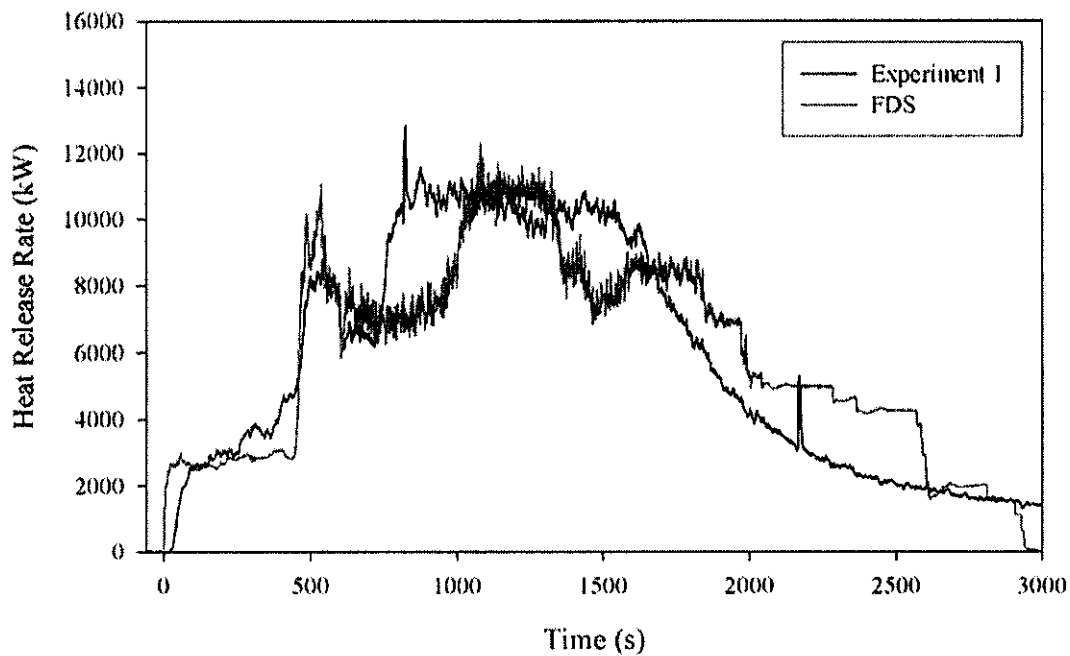
Figure 6–35. Measured and predicted heat release rate from the burning of three office workstations.

The differences in the fire behavior under the different experimental conditions were profound in these roughly hour-long tests. The jet fuel greatly accelerated the fire growth. Only about 60 percent of the

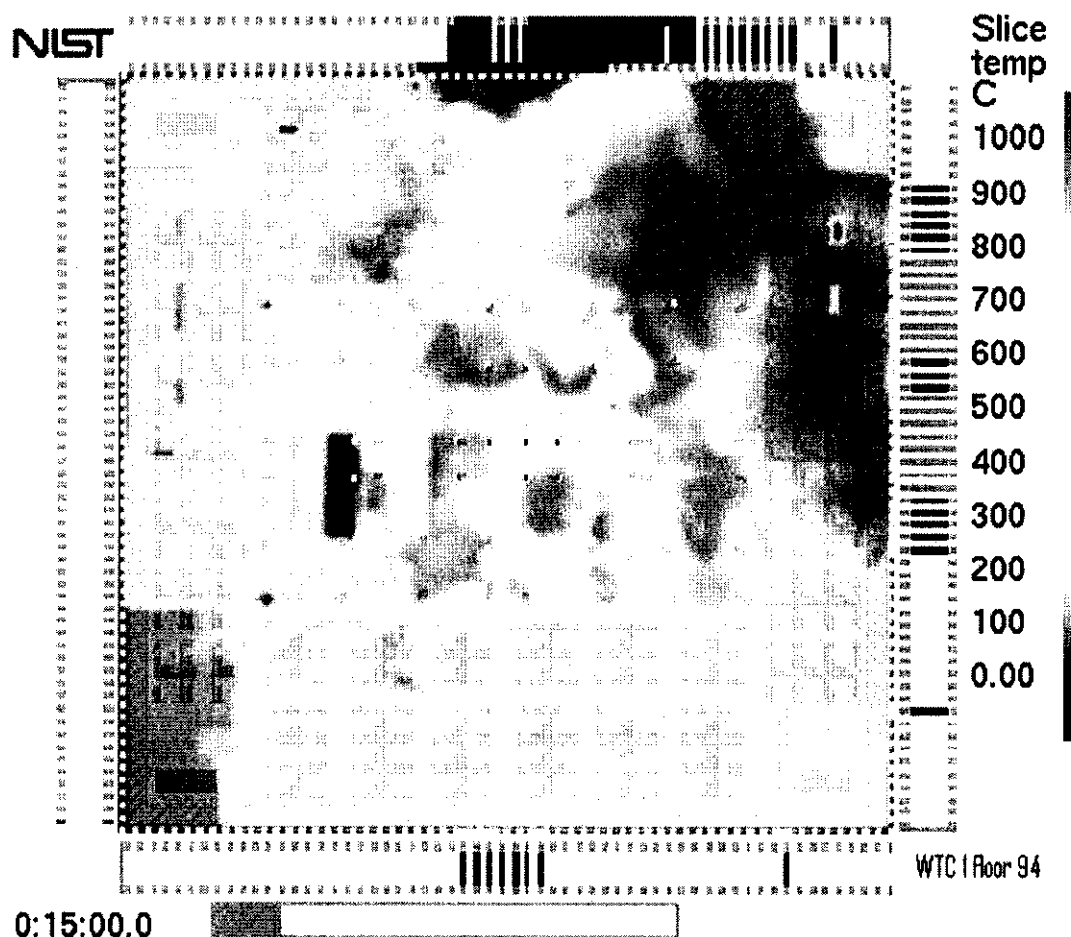
For each of the four scenarios, FDS was used to generate a time-dependent gas temperature and radiation environment on each of the floors. The results of the FDS simulations of the perimeter fire were compared with the fire duration and spread rate as seen in the photographs and videos. For ease of visualization, contour plots of the room gas temperature 1.3 ft below the ceiling slab (in the “upper layer” of the compartment) were superimposed on profiles of the photographed fire activity. An example is shown in Figure 6–36. The stripes surrounding the image represent a summary of the visual observations of the windows, with the black stripes denoting broken windows, the orange stripes denoting external flaming, and the yellow stripes denoting fires that were seen inside the building. Fires deeper than a few meters inside the building could not be seen because of the smoke obscuration and the steep viewing angle of nearly all the photographs.

Figure 6–36. Upper layer temperatures on the 94th floor of WTC 1, 15 min after impact.

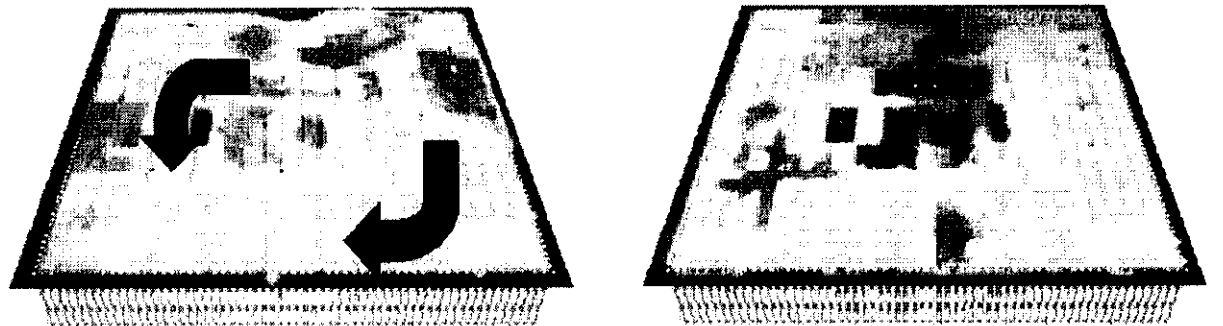
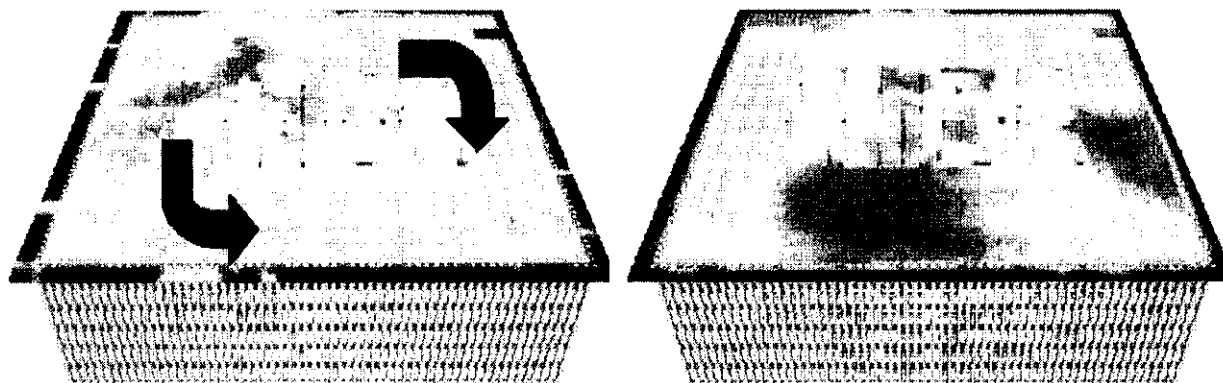
Much of the fire activity was initially in the vicinity of the impact area in the north part of the building. As a result of the orientation of the impacting aircraft and its fuel tanks, the early fires on the 92nd through 94th floors tended toward the east side of the north face, while the early fires on the 97th through 99th floors tended toward the west side of the north face. The fires on all the floors spread along the east and west sides and were concentrated in the south part of the building at the time of collapse, as depicted in Figure 6–37.

Figure 6–37. Direction of simulated fire movement on floors 94 and 97 of WTC 1.

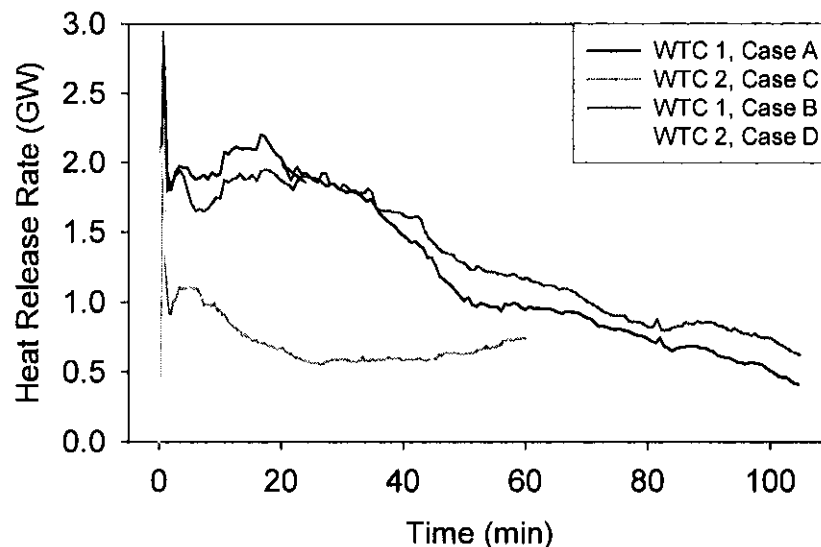
Much of the information needed to simulate the fires came from laboratory-scale tests. While some of these involved enclosures several meters in dimension and fires that reached heat release rates of 10 MW and 12 GJ in total heat output, they were still far smaller than the fires that burned in the WTC towers. Figure 6–38 shows the heat release rates from the FDS simulations of the WTC fires. The peak plateau heat release rates were about 2 GW for WTC 1 and 1 GW for WTC 2. Integrating the areas under these curves produced total heat outputs from the simulated fires of about 8,000 GJ from WTC 1 and 3,000 GJ from WTC 2.

Figure 6–38. Predicted heat release rates for fires in WTC 1 and WTC 2.

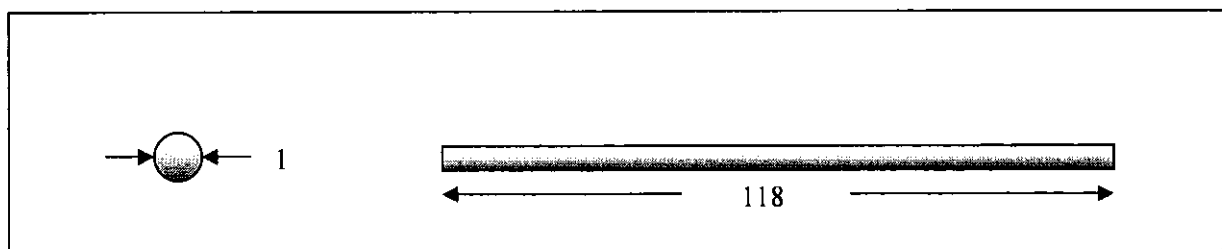
Figure 6-39. Simple bar dimensions (in.).

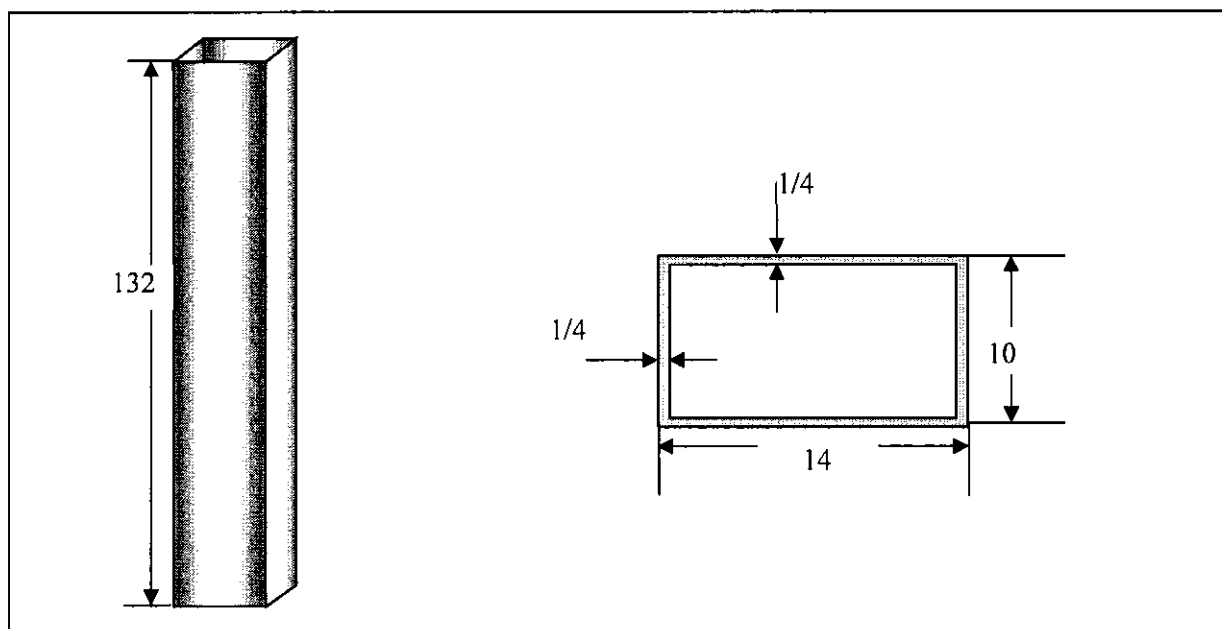
Figure 6-40. Tubular column dimensions (in.).

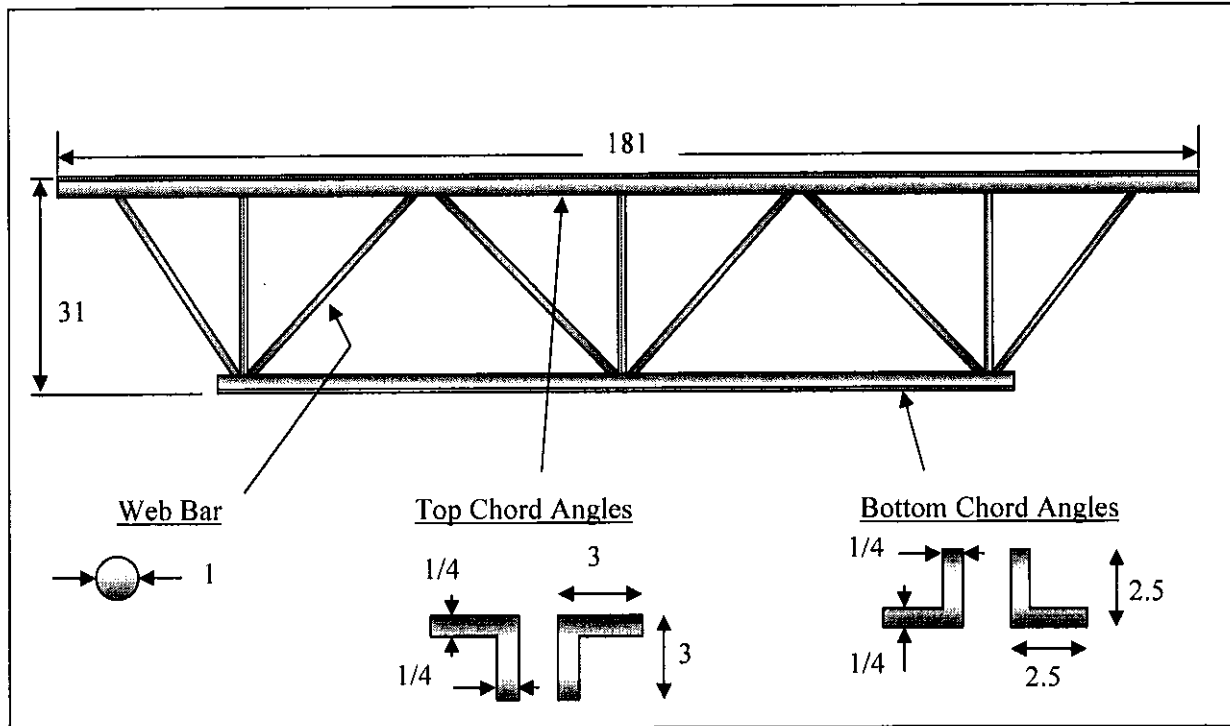
Figure 6-41. Truss Dimensions (in.).

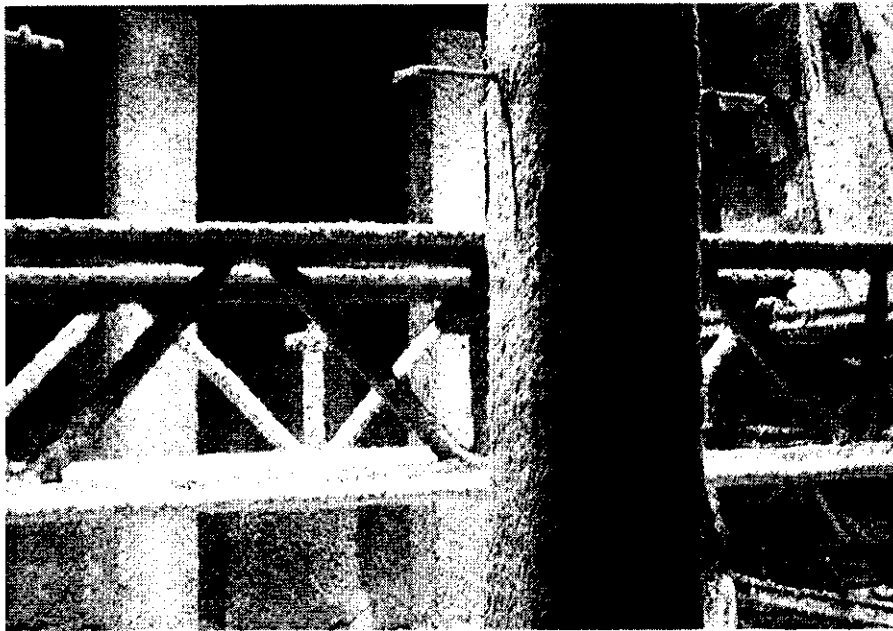
experienced applicator, who took considerable care to apply an even coating of the specified thickness. As such, the insulated test subjects represent a best case in terms of thickness and uniformity. Figure 6-42 shows some of the coated components.

Figure 6-42. SFRM-coated steel components prior to a test.
